**DYNAMIC LOAD TESTING OF SAFE-T-STRAP ANCHOR ATTACHED TO A
RESIDENTIAL TIMBER TRUSS FOR THE ATTACHMENT OF FALL ARREST
EQUIPMENT OF ROOFERS**

***Original report dated November 22, 2002- Revised May 22, 2013 to clarify the test
results.***

Ralph Balbaa, M.Eng., P.Eng.,
HITE Engineering Corporation
May 22, 2013

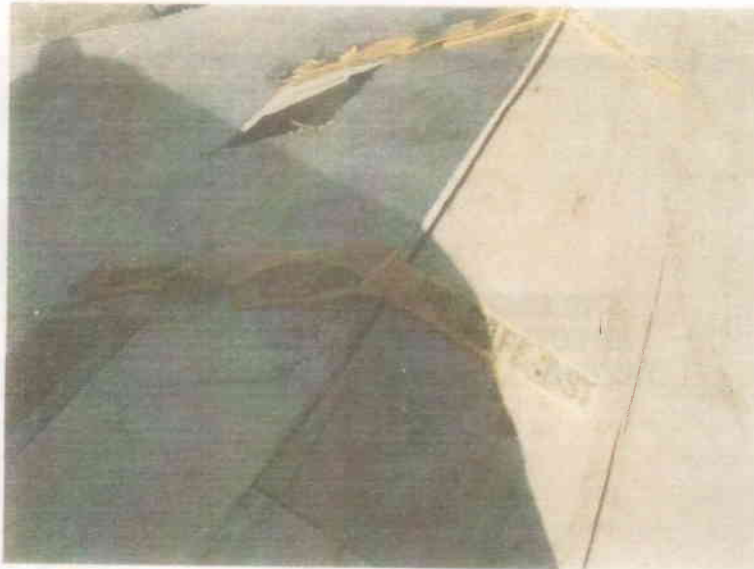
The anchors were nailed to the 2 x 4 top chord a residential truss through the plywood sheathing at the ridge.

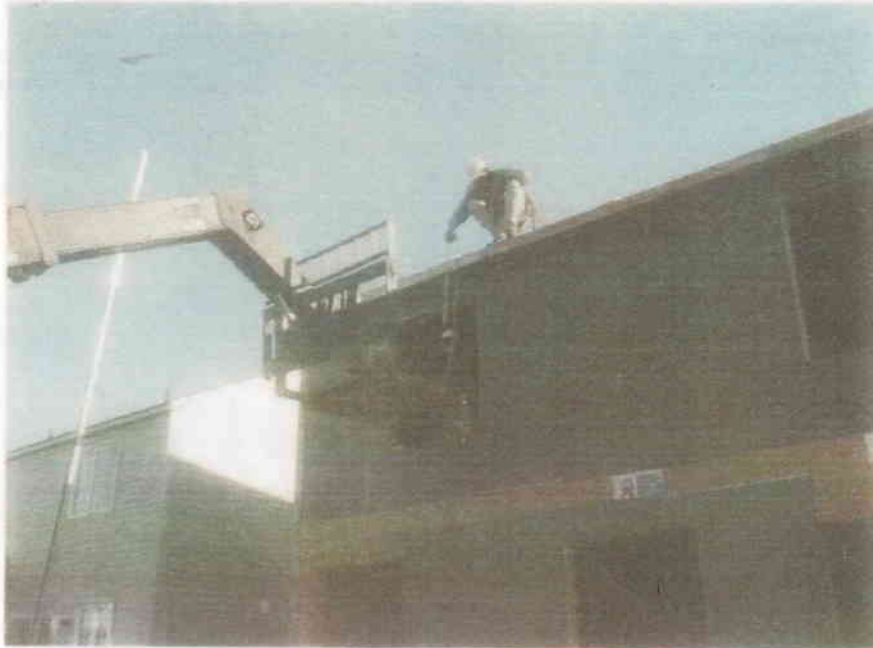
A forklift raised the loads to the point where there was a measured 4' slack in the chain.

The weights were then allowed to free-fall a distance of 4'.

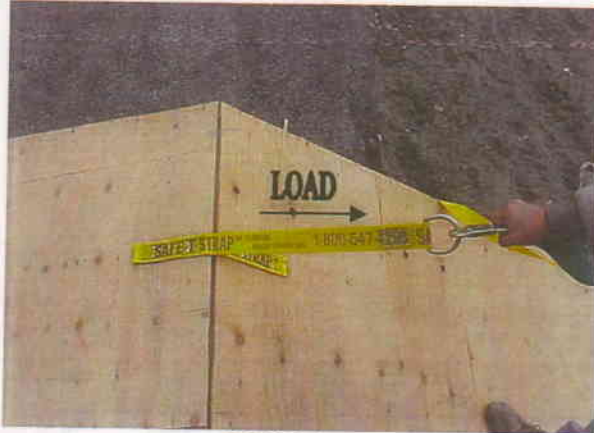
TEST 1
Load Perpendicular to nailed strap

At the Ajax site, those tested with the load free-falling the perpendicular direction, no signs of failure or distress was exhibited.

The average force registered on the dynamometer was 850 lbs.

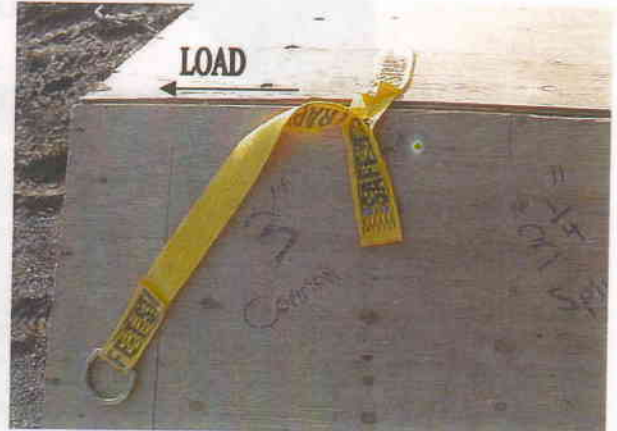
TEST 2
Load Parallel to nailed strap
